CANTERBURY MANOR SANITARY INVESTIGATION FEBRUARY 11, 2016

ROBERT P. KELLY, P.E. DIRECTOR OF ENGINEERING CITY OF WESTLAKE 440-617-4145

RADCLIFFE DRIVE BASEMENT WATER INFILTRATION STUDY

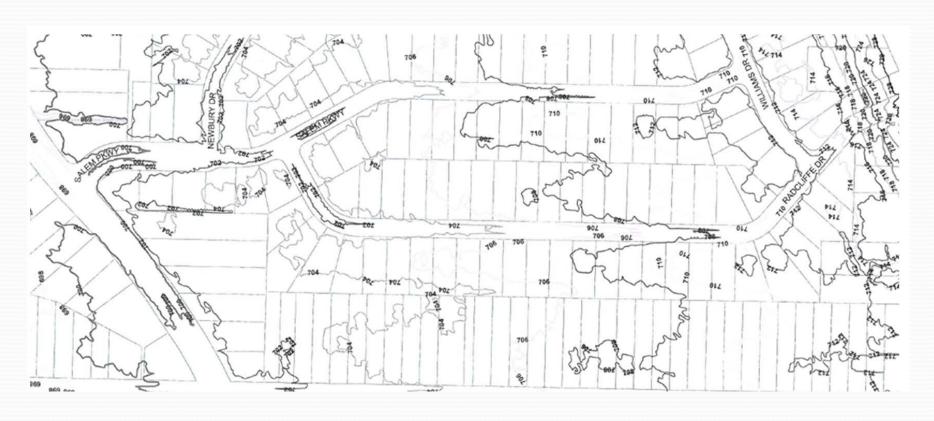
SUBDIVISION GRADING

RADCLIFFE IS LOWER IN ELEVATION THAN SALEM PKWY. SO THE BASEMENT FLOOR ELEVATIONS ARE CLOSER TO THE SEWER ELEVATIONS.

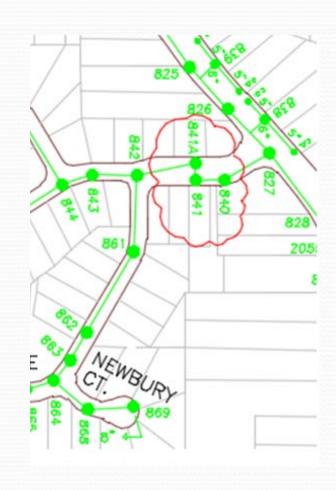
"DOG LEG" ALIGNMENT

- THIS ONLY RESULTS IN THE SANITARY SURCHARGE ELEVATION TO BE INCREASED BY ONLY ABOUT 1" WITH BOTH 90° BENDS.
- "THIS DOES NOT SIGNIFICANTLY CONTRIBUTE TO BASEMENT WATER INFILTRATION"

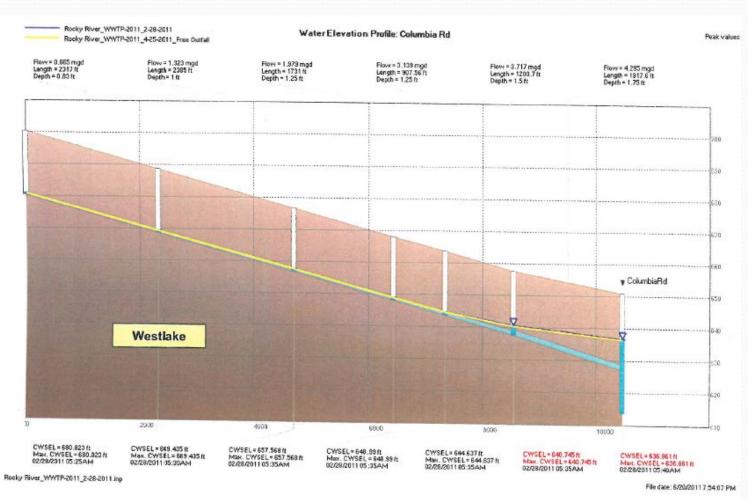
COLUMBIA

Hydraulic grade line along Westlake Interceptor Blue HGL is existing Condition; Yellow HGL is free outfall condition

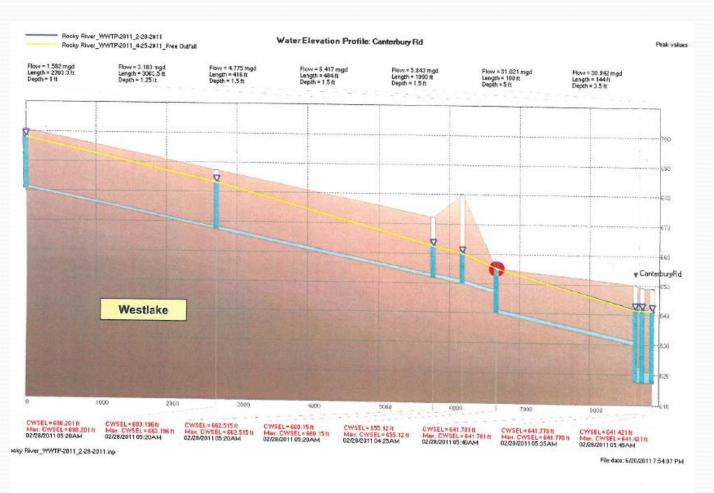
CANTERBURY

Hydraulic grade line along Westlake Interceptor Blue HGL is existing Condition; Yellow HGL is free outfall condition

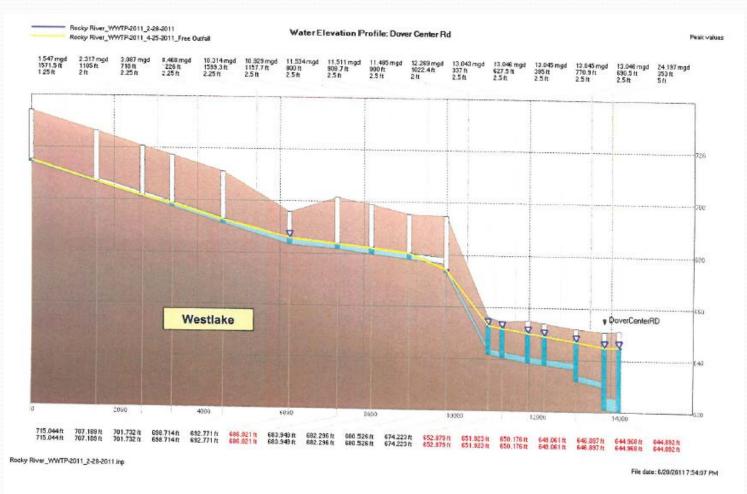
DOVER CENTER

Hydraulic grade line along Westlake Interceptor Blue HGL is existing Condition; Yellow HGL is free outfall condition

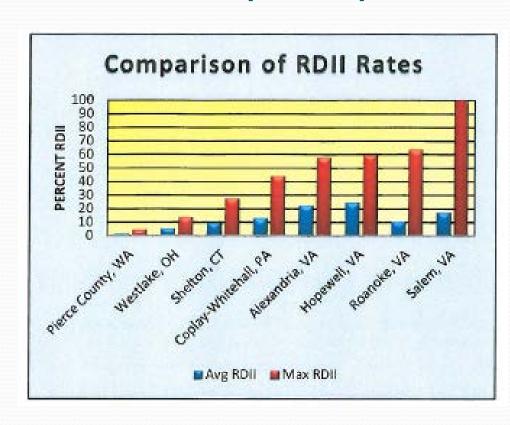
RAINFALL DERIVED INFLOW/INFILTRATION(RDII)

- COMPARISON TO
 OTHER SANITARY
 SYSTEMS STUDIED BY
 ADS. THE HIGHER THE
 BAR THE "LEAKIER"
 THE SEWER.
- SINCE RDII IS LOW IT IS DIFFICULT TO ELIMINATE

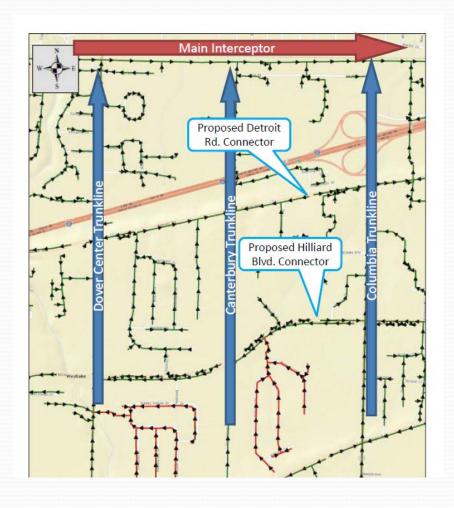
SANITARY BY-PASS

- COLUMBIA TRUNK LINE HAS SOME CAPACITY DURING A RAIN EVENT
- SOME OF CANTERBURY SEWAGE WILL BE BY-PASSED TO COLUMBIA
- MODELING WILL DETERMINE EFFECTIVENESS AND TO VERIFY NO ISSUES OCCUR ON COLUMBIA
