Lessons Learned During Sewer Rehabilitation on Public and Private Property City of Westlake, Ohio

Scott E. Belz
Project Manager- URS Corporation

Robert P. Kelly, P.E.
Director of Engineering-City of Westlake

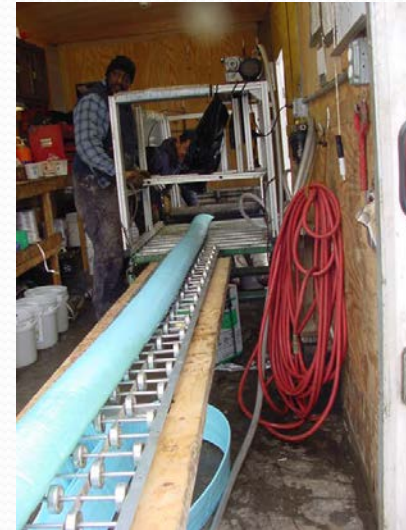
- Some failures of the CIPP lining occurred. Probably from ambient cure in cool weather
- A carpet roller was used in lieu of a nip roller to wet out the liner. This could have resulted in some failures of the lateral CIPP
- The majority of the storm and sanitary laterals were more than 10' apart. So an additional excavation had to occur since both could not be exposed in the same pit
- The storm main was not inspected prior to project and many point repairs had to occur

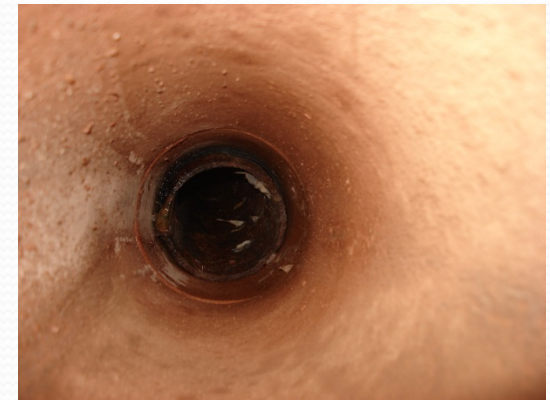
- The majority of the homes had branch connections due to septic tank conversions that could not be lined
- Some homes failed the post dye test
 - The unlined branch connection had infiltration from a compromised DS leader
 - The liner had to end short of the foundation due to a 4" reducer

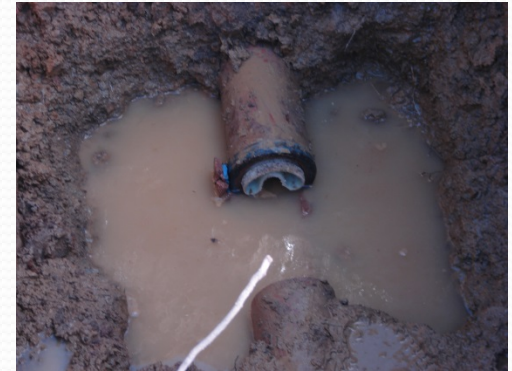
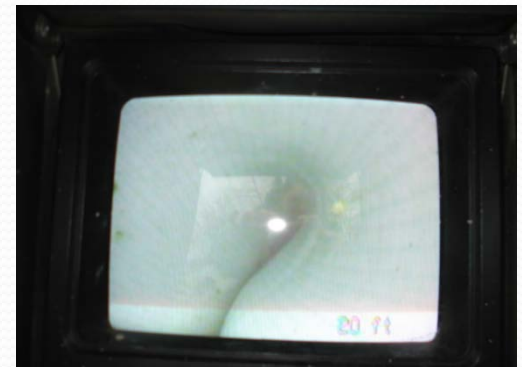
- Some CIPP laterals failed due to workmanship
 - The resin was not cured properly
 - The resin was not properly measured due to faulty equipment
 - The calibration bladder was pulled prior to cure
 - Calibration bladder was installed to short
 - The liner was installed to short from pit to main

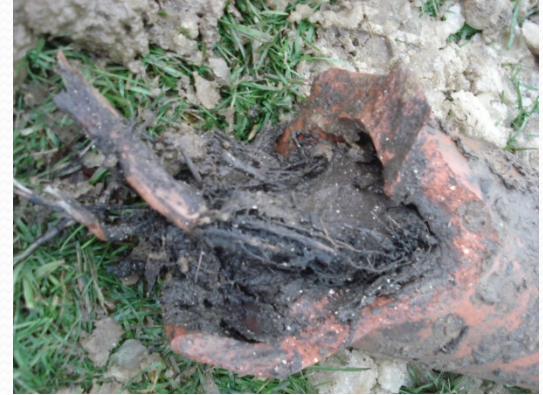
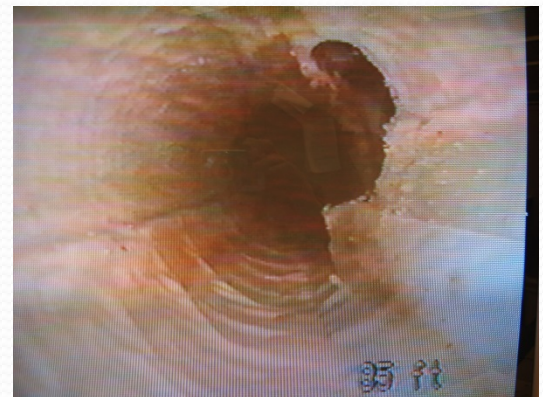
- For some homes the downspout leaders were compromised from roots and or broken pipe
- Some of the sanitary laterals wrapped around the rear of the house with footages beyond 100'
- Reinstatements of branch connections by open cut with a saw yielded frayed edges.

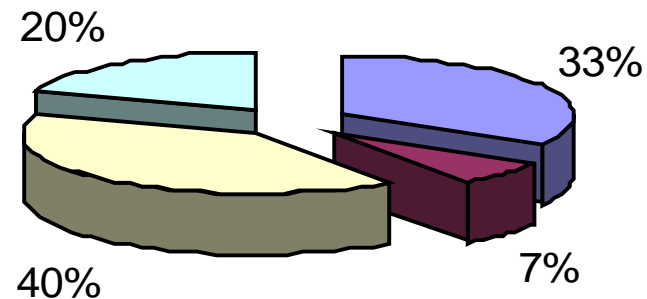
WESTHILL / ALLEN SUBDIVISION 97 HOMES TESTED

- NO ISSUES
- MAINLINE TESTING-ISSUE
- POSITIVE DYE-RESIDENTIAL
- CLEAR WATER-RESIDENTIAL

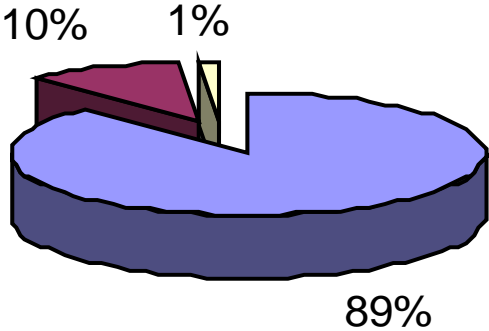
MELROSE SUBDIVISION 67 HOMES TESTED

- NO ISSUES
- POSITIVE DYE-RESIDENTIAL
- CLEAR WATER-RESIDENTIAL

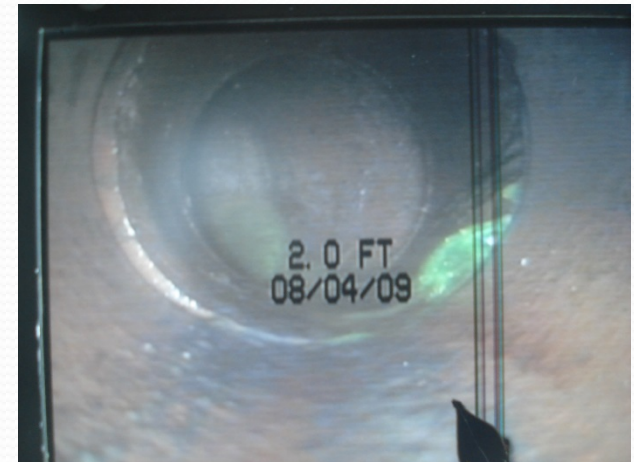
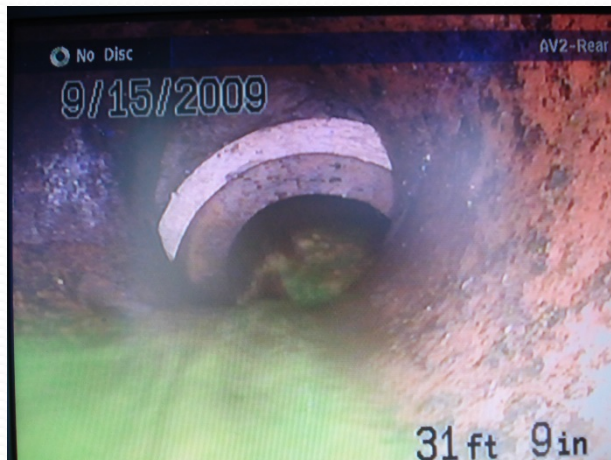
- Common found deficiencies
 - Sanitary Joint Infiltration
 - Compromised DS Leader
 - Storm Connection blocked
