FOCUS: SEWER

LEARNING BY DOING

A step-by-step approach helps an Ohio community refine its sewer rehabilitation methods, reduce I&I substantially, and save money

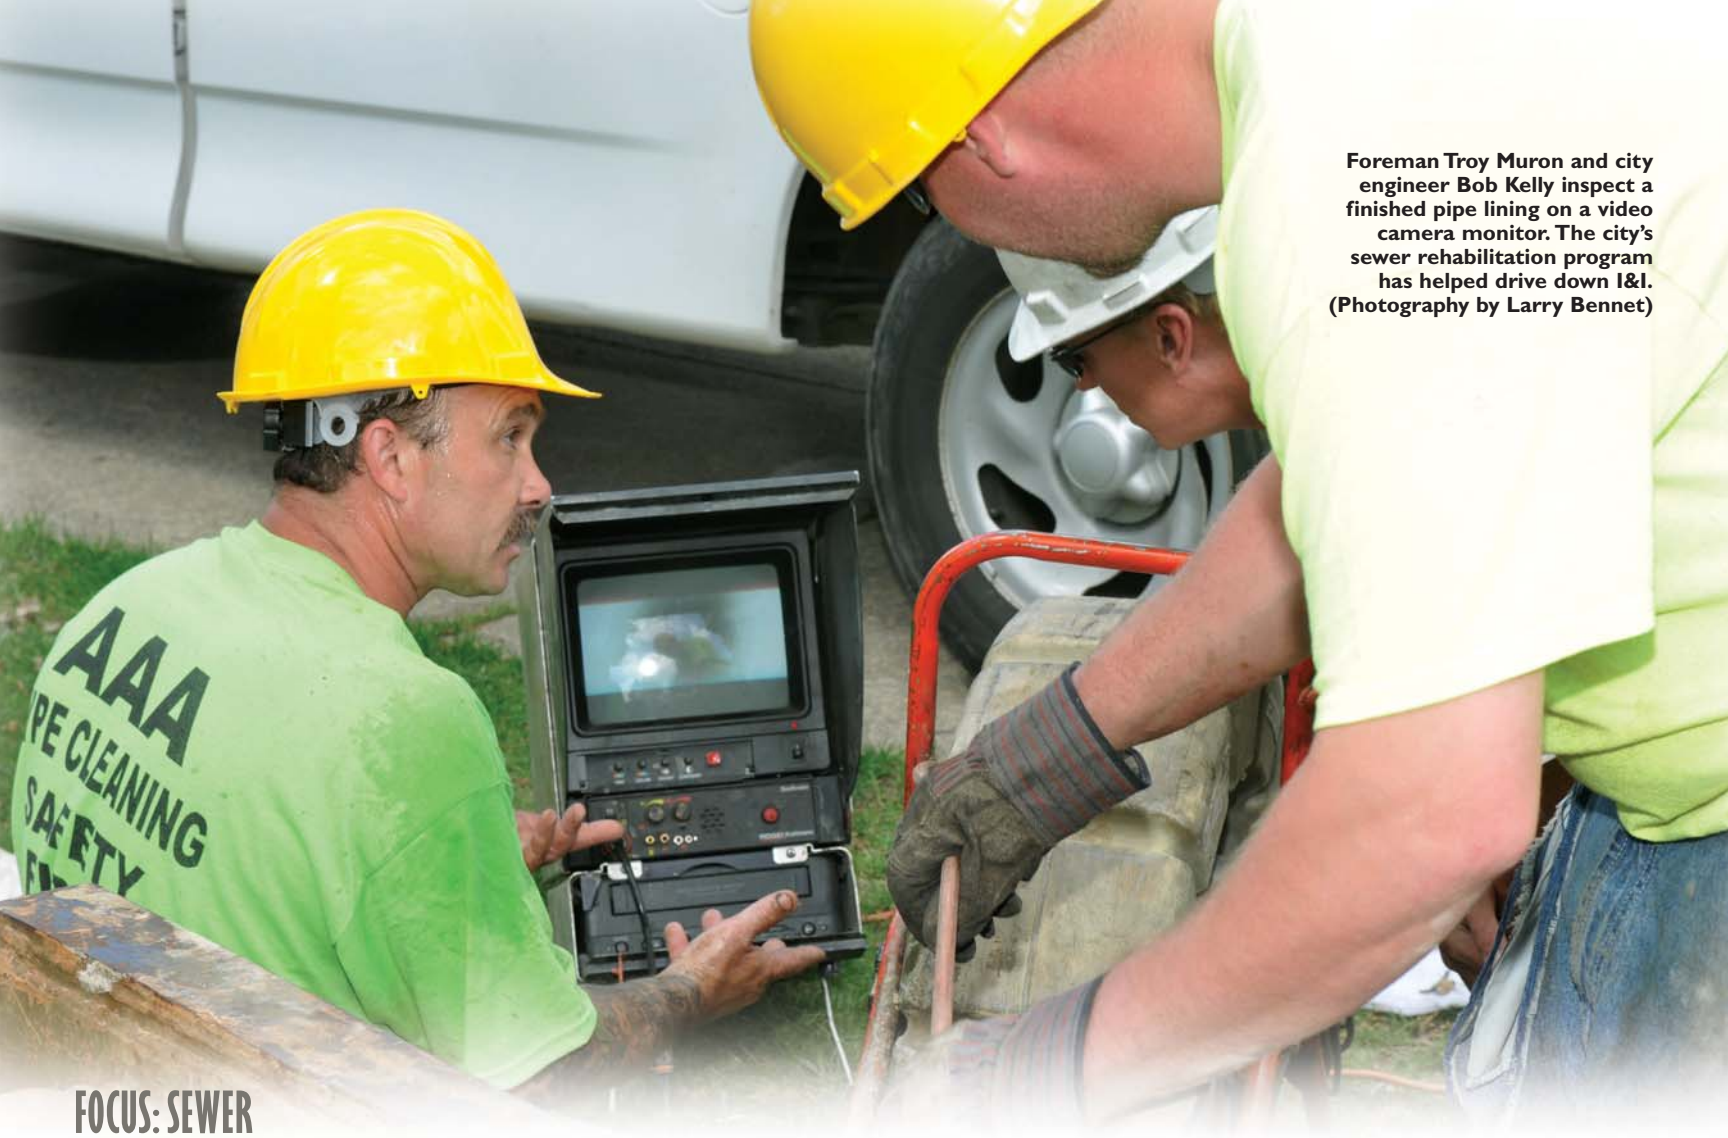
Foreman Troy Muron and city engineer Bob Kelly inspect a finished pipe lining on a video camera monitor. The city's sewer rehabilitation program has helped drive down I&I. (Photography by Larry Bennet)

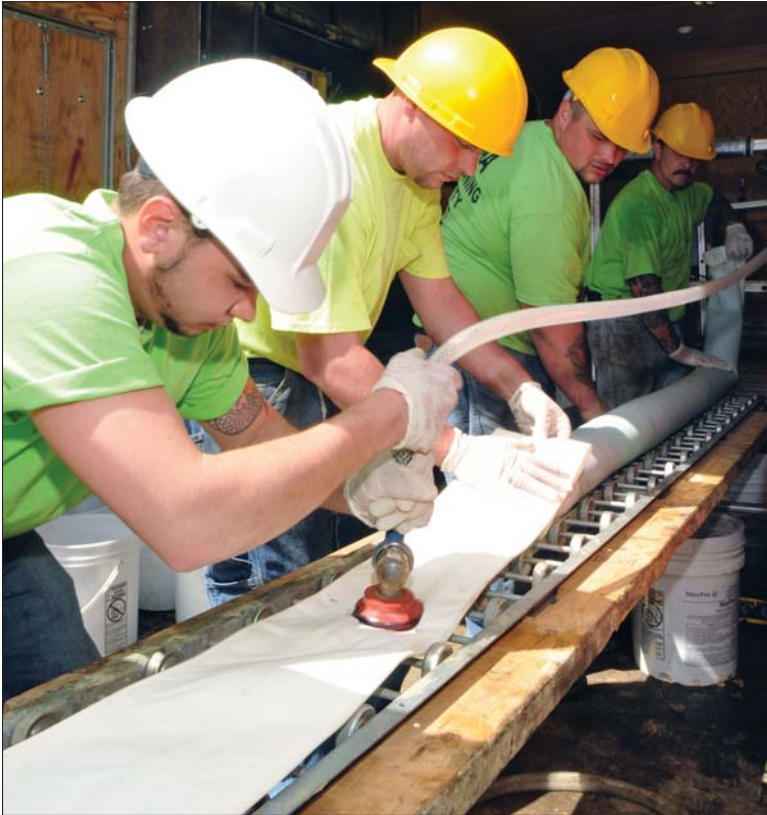
Westlake crew members Joshua Muron, Bobby Vernatter, Neil Sobodinski and Troy Muron work on the wet-out assembly line on a CIPP lining project.

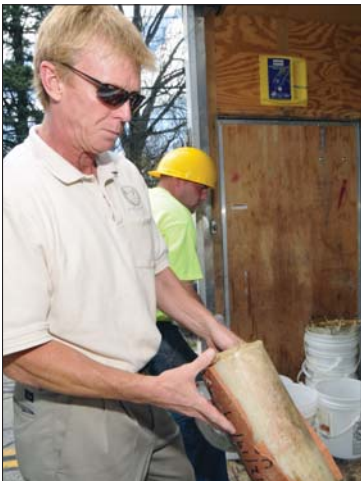
City engineer Bob Kelly examines a sample of CIPP lining. The city collects neighborhood data for about a year to develop the most cost-effective I&I solutions available.

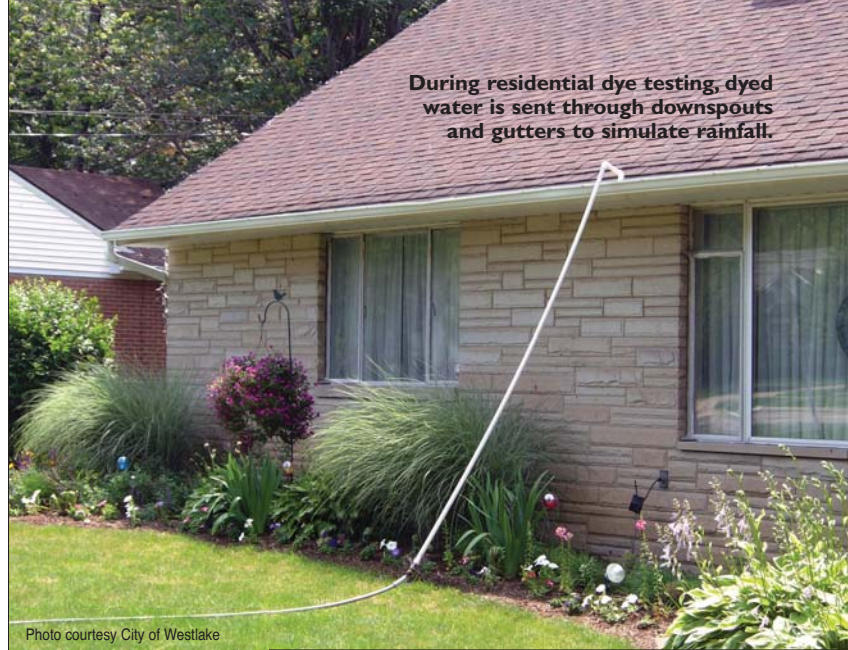
During residential dye testing, dyed water is sent through downspouts and gutters to simulate rainfall.

To pinpoint the sources of infiltration and inflow in Westlake, Ohio, URS Corp. developed a unique method of dye testing using water from fire hydrants.

A specially designed PVC manifold steps the water flow down from fire hose to garden hose volume, and can distribute the flow to several hoses at once. Different-colored dye solutions are then applied to downspouts, foundations, driveways and other potential sources of I&I.

CCTV units monitor the sewer lateral for traces of the dye, which can then be tied back to the source of the leakage. “We knock on doors and ask the homeowner to turn off the water for 15 to 20 minutes while we run the test,” says Scott Belz, field manager of the water resources group of URS. “They’ve already been notified of the procedure by the city, so they’re usually very cooperative.”

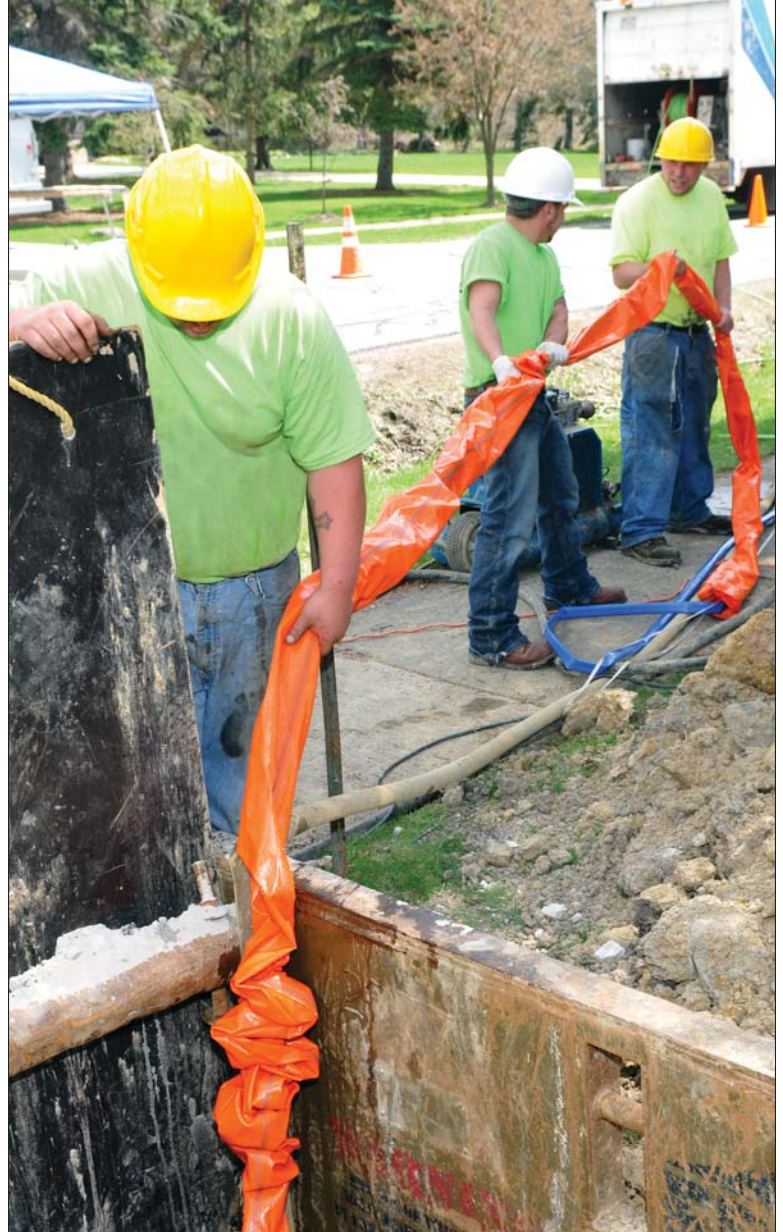
Crew members Neil Sobodinski, Joshua Muron and Bobby Vernatter help extract the calibration bladder assembly, which includes a recycle hose and extraction cord.
