CANTERBURY MANOR SANITARY INVESTIGATION FEBRUARY 11, 2016

ROBERT P. KELLY, P.E. DIRECTOR OF ENGINEERING CITY OF WESTLAKE 440-617-4145

RADCLIFFE DRIVE BASEMENT WATER INFILTRATION STUDY

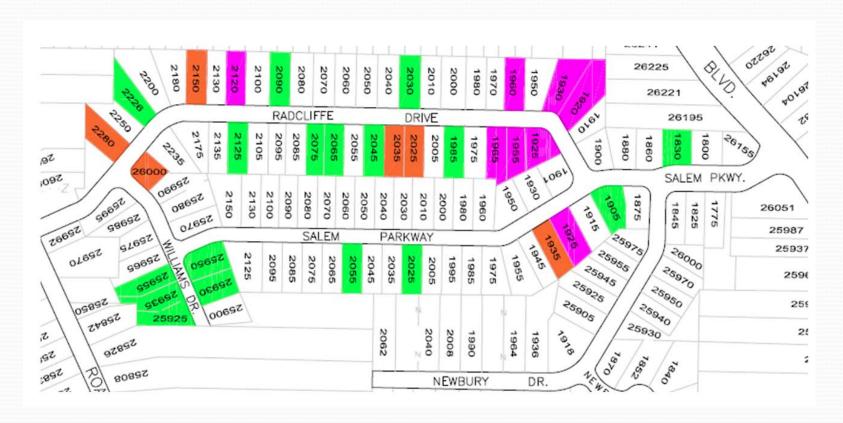
DYE TEST RESULTS

SANITARY SURCHARGE STORM SURCHARGE AND/ OR PLUMBING ISSUE COMBINATION OF BOTH

- R.E. WARNER ANALYZED THE FOLLOWING DYE TEST RESULT TO VERIFY GOOD SOUND ENGINEERING PRACTICE WAS BEING PERFORMED:
 - 1920 RADCLIFFE
 - 1930 RADCLIFFE
 - 2025 RADCLIFFE
- "TESTING PROCEDURE AND RECOMMENDATIONS APPEAR TO BE SOUND WITH GOOD ENGINEERING PRACTICES."

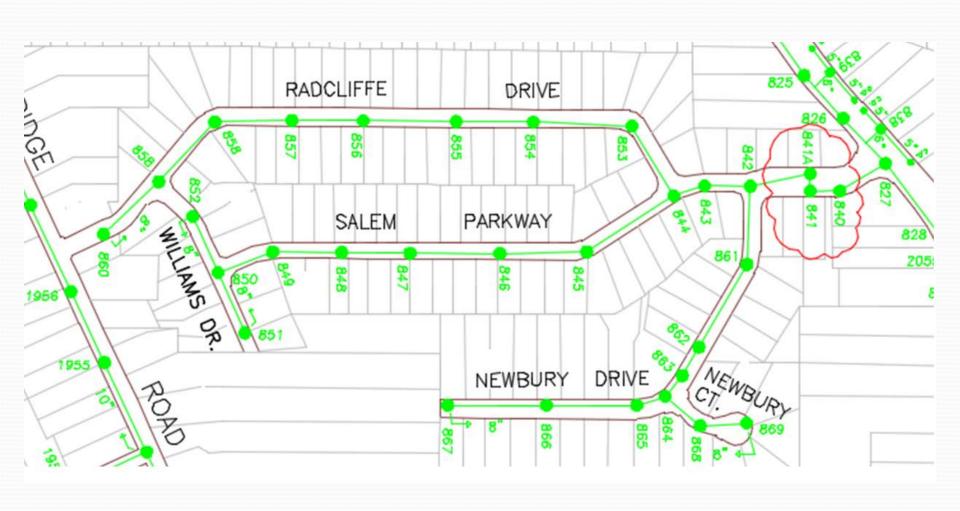
SANITARY SEWER SYSTEM

"DOG LEG" ALIGNMENT

- THIS ONLY RESULTS IN THE SANITARY SURCHARGE ELEVATION TO BE INCREASED BY ONLY ABOUT 1" WITH BOTH 90° BENDS.
- "THIS DOES NOT SIGNIFICANTLY CONTRIBUTE TO BASEMENT WATER INFILTRATION"

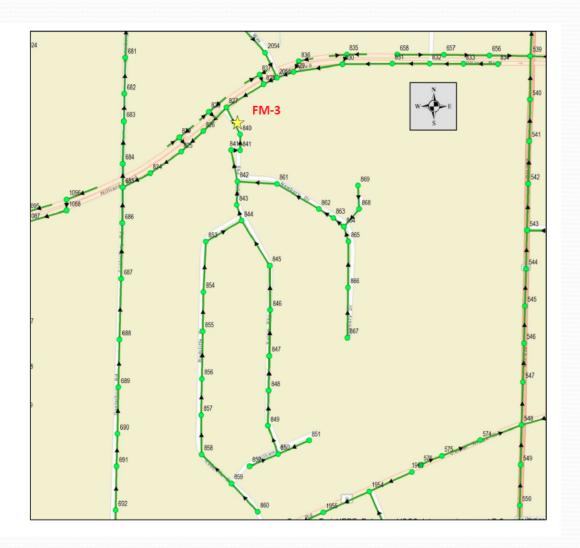
CANTERBURY MANOR FLOW METER

CANTERBURY
 ESTATES IS IN BASIN
 CANo4 AND IS
 CONSIDERED TO
 HAVE AN EXCESSIVE
 AMOUNT OF I/I.

- Flow Meter 3 located on Salem Pkwy.
- Monitored between Oct. 2015 and January 2016

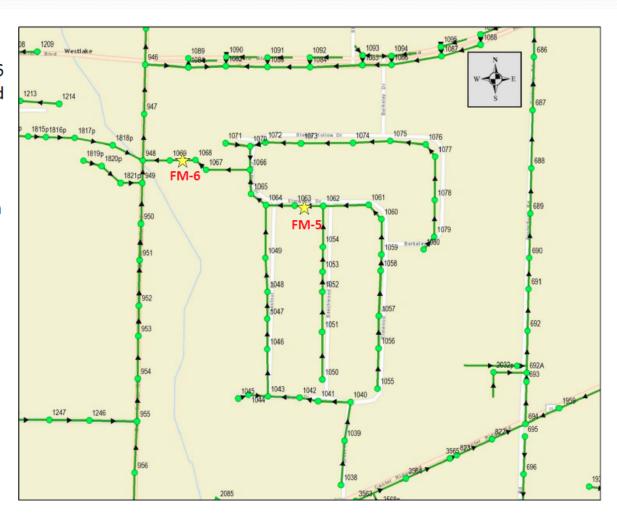
BERKELEY ESTATES FLOW METERS

- Flow Meters 5 and 6 located on Elmwood Rd. and east of Dover Center Rd., respectively.
- Monitored between Oct. 2015 and January 2016
