Lessons Learned During Sewer Rehabilitation on Public and Private Property City of Westlake, Ohio

Scott E. Belz
Project Manager- URS Corporation

Robert P. Kelly, P.E.
Director of Engineering-City of Westlake

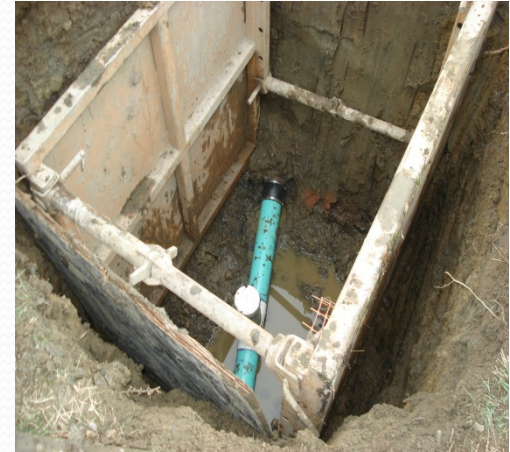
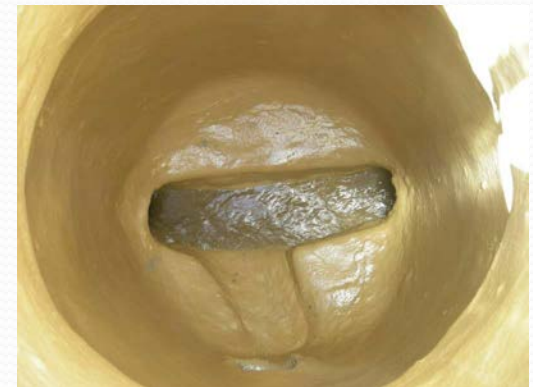
- Rehabilitation of the laterals was done with CIPP
 - Installed from excavated entry pits and liner inserted with rods, not pressure
 - Steam Curing
 - CIPP provided structural improvements over grout.
- Testing
 - Pre and Post flow monitoring
 - Pre and Post dye testing
- Manhole Rehabilitation
 - Manhole Sealing was sprayed-on Polyurethane Liner from invert to casting.

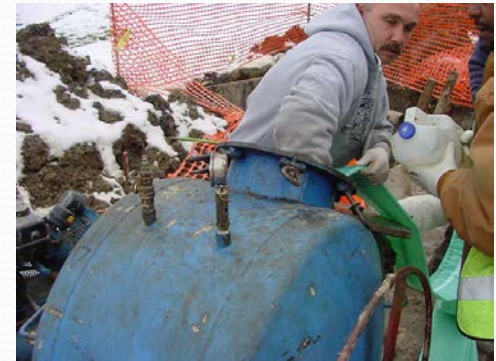
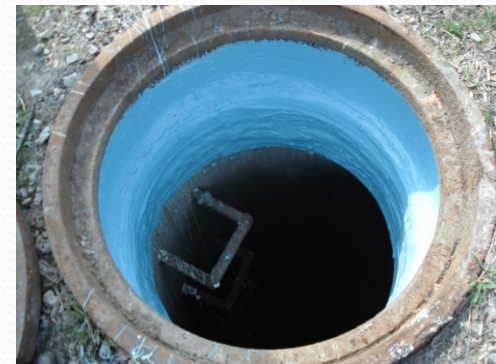
- Work performed in 2004
- CIPP Lateral rehabilitation was done in the same fashion as previous project with the following changes
 - A pressure launching vessel was used for inversion
 - The lateral to mainline interface was grouted with a lateral packer
 - Ambient cure was used
- Sanitary Mainline
 - Sectional chemical grouting of joints
- Sanitary Manhole Rehabilitation
 - Cementitious coating
 - Flexible urethane product was used at grade ring

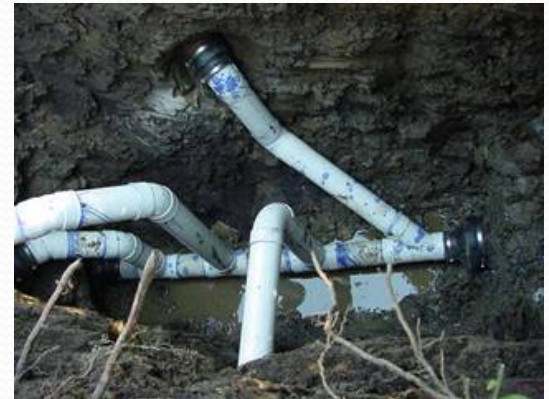
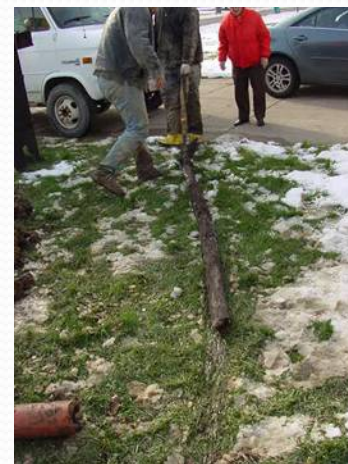
- The status of the existing downspout leaders and storm connection is critical.
- If the storm connection is compromised then eliminating I/I on the private side will be difficult
- More research needs to be done during the design to verify the estimated footages of the sanitary connections and the number of possible branch connections by reviewing basement plumbing

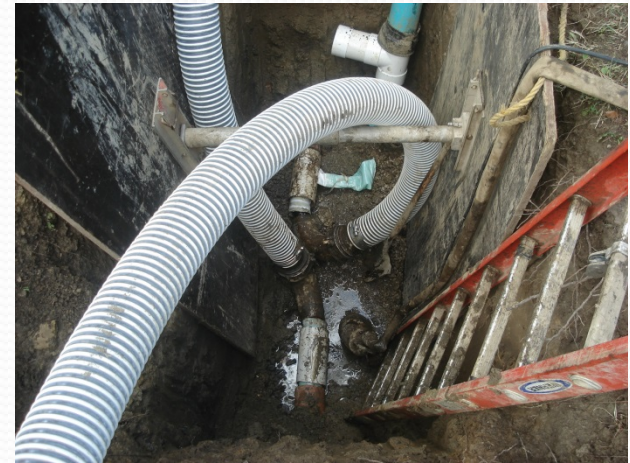
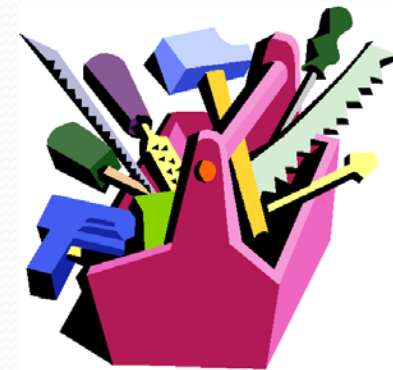
- Historical Method
 - Use CIPP Lining
 - Positive Res. Test
 - Clear Water Infiltration
 - Positive Mainline Test
- New Approach
 - Use all the tools in the tool box
 - Grouting
 - CIPP
 - Cleaning
 - Point Repairs
 - Use appropriate method of rehab.
 - Do not rely solely on CIPP.
