## Capital Circle 36-in. Force Main Pipe Bursting Repair Pilot

## Westlake Sanitary Interceptor Treatment Project

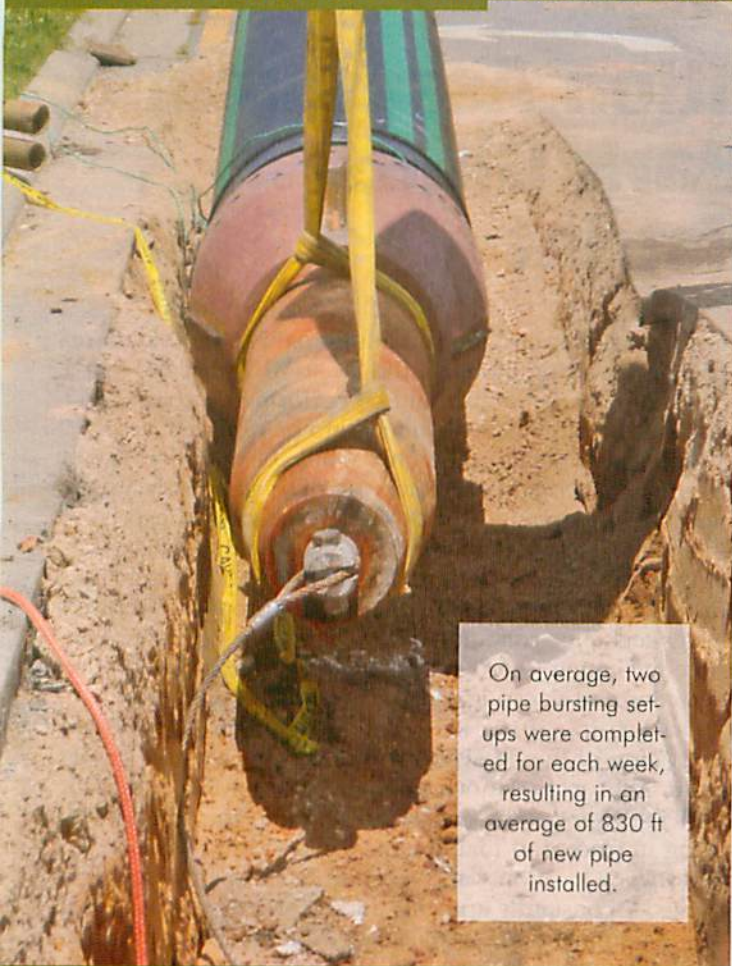
On average, two pipe bursting setups were completed for each week, resulting in an average of 830 ft of new pipe installed.

In August 2008, the City of Tallahassee, Fla., experienced extensive rainfall as a result of tropical storm Fay. The heavy rain caused three pipe breaks in the city's Capital Circle Roadway Force Main. Since the roadway is one of the busiest routes, the City of Tallahassee contracted MWH to evaluate the damage and examine trenchless repair options. Pipe bursting was selected, especially to maintain the current flow capacity of the existing force main. From there, MWH engineers designed a pipe bursting pilot for a 280-ft section of a 36-in. diameter HOBAS force main, replacing it with 36-in. PE4710 pipe. In order to effectively and quickly repair the damage, the city divided the repair into three separate projects. On average, two pipe bursting setups were completed for each week, resulting in an average of 830 ft of new pipe installed per week. Construction on the project was completed in February 2010.

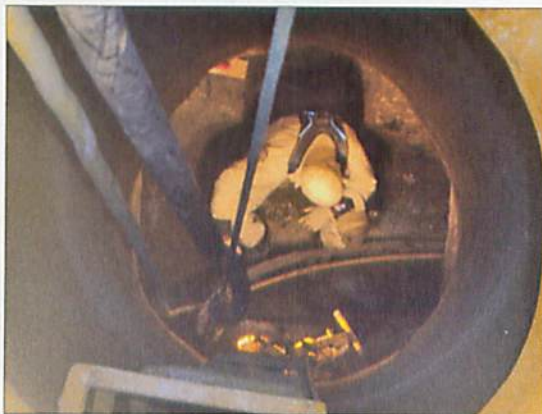
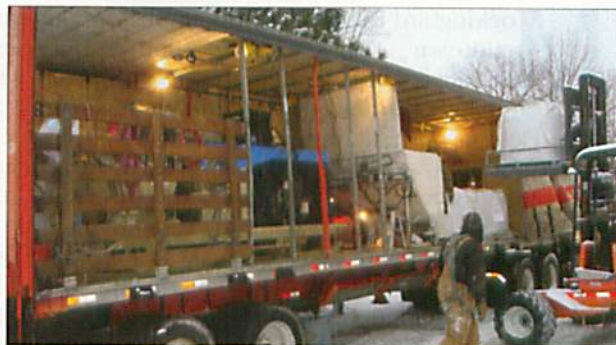
Using the pumped cementitious coating, the City of Westlake rehabilitated 3,961 lf of pipe and saved around \$1.5 million over other rehab options.

After a condition assessment of its sanitary interceptor, the City of Westlake, Ohio, discovered that various sections of pipe had corroded because of hydrogen sulfide. If not treated, this corrosion could lead to structural failure of the pipe. In order to prevent this from happening, the city decided to perform the rehabilitation by using a spray-applied cementitious coating with an antimicrobial agent called ConShield, which is manufactured by AP/M Permaform. By using a process known as centrifugally cast concrete pipe (CCCP), the coating was applied on the surface of the prepared pipe by a spin caster at a thickness of a 1/2 in. The spin caster was pulled at a uniform rate and applied the cementitious coating 360 degrees around the circumference of the pipe with compressed air. Using the pumped cementitious coating, the City of Westlake rehabilitated 3,961 lf of pipe and saved around \$1.5 million over other rehab options.
